## The bituminous geomembrane

This first issue of COLETANCHE® NEWS covers the application of COLETANCHE® as a liner for irrigation canals.

## Application in canals in Oregon and Washington

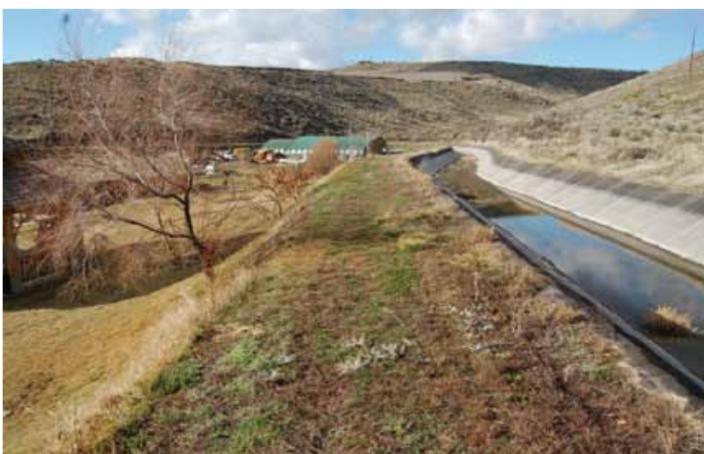
### Black Canyon, Idaho - 2003

COLETANCHE® was used to line this concrete canal on a side slope to provide a watertight lining and prevent water leakage that could lead to slope instability and failure. COLETANCHE® has been exposed year round in this canal since 2003. Including part of the year when no irrigation water is needed and the canal is empty. The low Manning coefficient allows for minimal head losses. Denser than water, COLETANCHE® lies flat against the wall and bottom of canal when it is full of water.

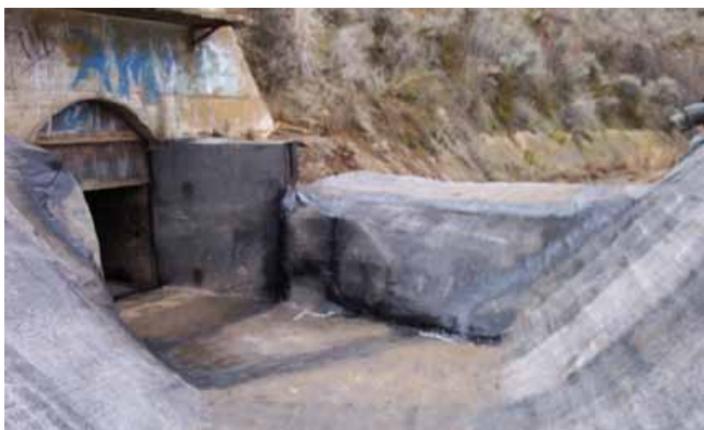
### Yakima, WA - 2003

COLETANCHE® can be bonded to any surface and to most materials to provide a watertight seal. It does not crack with time and can bridge openings and fissures up to one inch wide in concrete lining. Complex geometry and interfaces can be negotiated easily as shown at the connection between the concrete lined canal and the tunnel in take.

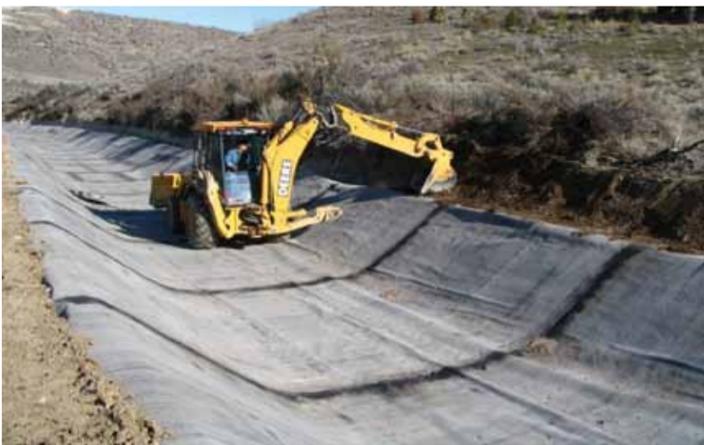
### Naches, WA - 2006

A heavy duty geomembrane with a strong resistance to puncture, COLETANCHE® can sustain vehicular traffic. Annual maintenance, prior to the irrigation season, is performed in this earthen canal lined with COLETANCHE®, using standard construction equipment. Note that adjacent segments of COLETANCHE® are shingled in the direction of flow.

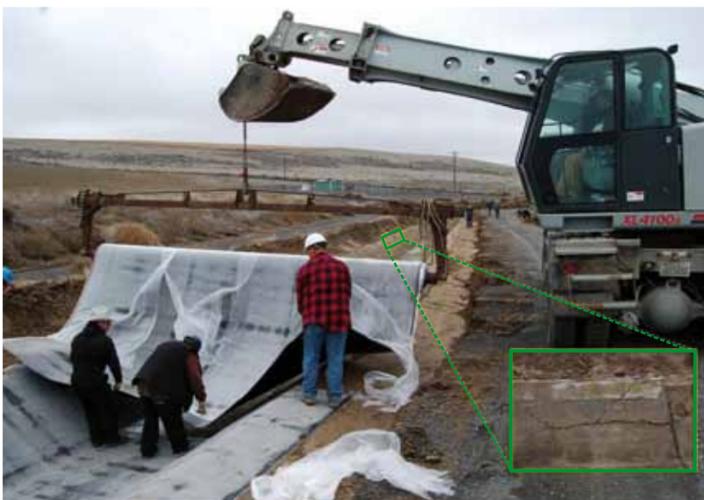
### Naches, WA - 2009

Installation of COLETANCHE® over a damaged concrete-lined canal. COLETANCHE® was laid out and seamed by the water district maintenance crew using simple equipment. Seaming is performed with a standard roofing torch and a propane bottle. COLETANCHE® seams do not require curing so water can be let in the canal immediately after installation. COLETANCHE® can be installed in hot or cold weather and even under misty conditions. Training for deployment and seaming is provided on site by COLETANCHE® personnel. Easy installation allows for schedule and budget flexibility.
