Protecting railway sub-grade with a reinforced bituminous geomembrane

G. LANGLEY, Colas Inc., B. BREUL, Colas SA,
E. SELIG, Ernest T. Selig, Inc., J. HYSLIP, Ernest T. Selig, Inc.

ABSTRACT: As part of a continuing effort to improve the reliability and efficiency of key sections of railway, The Burlington Northern and Santa Fe Railway Co. (BNSF) identified several sections of track requiring refurbishment. The problem was found to be related to the softening of the clay subgrade surface from water entering the track substructure. The solution that Engineers at BNSF chose was to treat the upper part of the clay with lime and cover the clay surface with bituminous geomembrane liner system to inhibit water from coming into contact with the surface of the plastic clay.

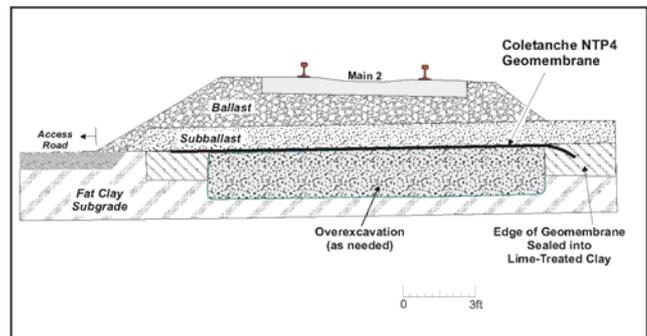
To eliminate the effects of water on lime-treated sulfate-rich soil, and flexural cracks in the subgrade, BNSF chose to use alternative 3 (Figure 1). Where the clay was stiff, the outer portion of the top of subgrade was stabilized by mixing in lime and compacting. In the center area, if the clay was stiff, the thin layer of toothpaste consistency clay was removed. In the case where the clay was soft to a greater depth, the clay was either lime stabilized or over excavated and replaced with subballast material. The membrane was placed on the prepared surface so that it extended past the center section. This sealed the subballast material from water infiltration and/or prevented the clay surface from coming into contact with water. Then the required thicknesses of subballast and ballast were placed on top of the membrane. The membrane was sloped to provide good drainage out of the track at the level of the top of the access road.

Figure 1: Design Cross Section

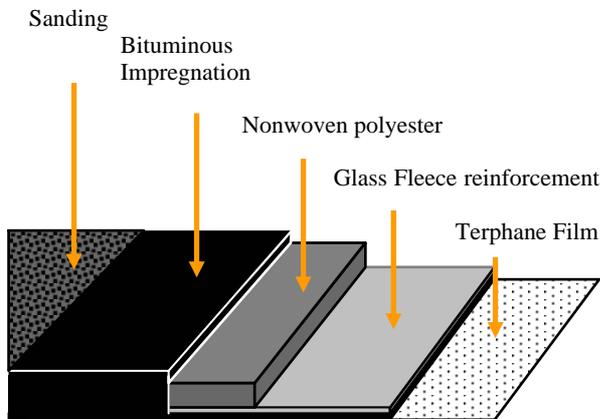
The structure of the geomembrane used is as follows (Figure 2):

- The base of the geomembrane is composed of
 - ◆ a nonwoven polyester geotextile whose mass per unit area is 400 grammes per m²
 - ◆ a glass fleece reinforcement which contributes to the strength of the geomembrane and stability during fabrication
 - ◆ the whole structure is impregnated with a compound including a blown bitumen of 100/40 pen plus filler
- The underside is coated with a Terphane film bonded when the membrane is hot, and designed to give resistance to penetration from tree roots
- Finally the upper surface is coated with a fine sand to a) provide greater traction on a slope, giving greater operator safety and security from slipping, and b) to give protection from the degrading effects of UV radiation

The sand side was placed against the clay subgrade leaving the Terphane film on the top side in contact with the subballast. This was done to optimize the sliding resistance between the membrane and the substructure layers.

Figure 2: Typical cross-section

The bituminous geomembrane used, Coletanche NTP4, is composed of; a combination of needle punched, non-woven geotextile, glass reinforcement and bituminous impregnation. This system results in a long life expectancy due to its resistance to high levels of mechanical stress and negligible ageing characteristics.

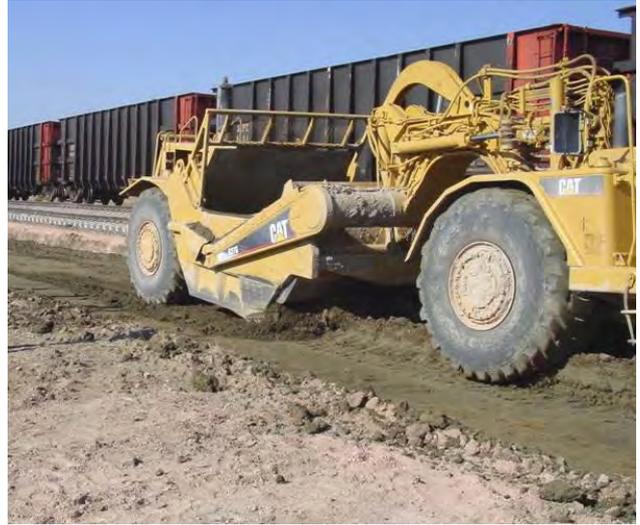
Preparation of the base involved the removal of the existing ballast, subballast and the very soft clay surface (Figure 3). In areas where the clay was soft, as observed by rutting from the scrapers (Figure 4) the soft material was excavated and replaced with subballast.

Figure 3: Base Preparation

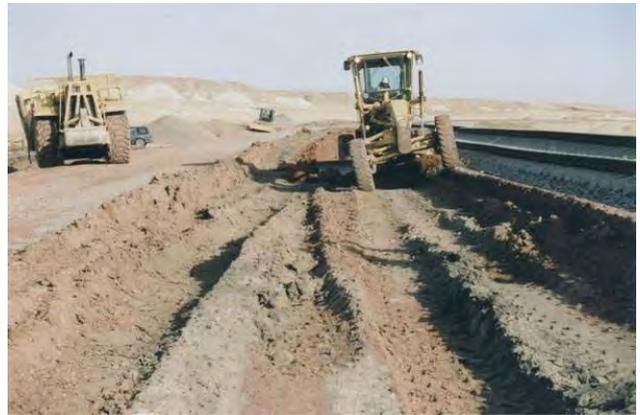
Figure 4: Base Preparation – Soft Area

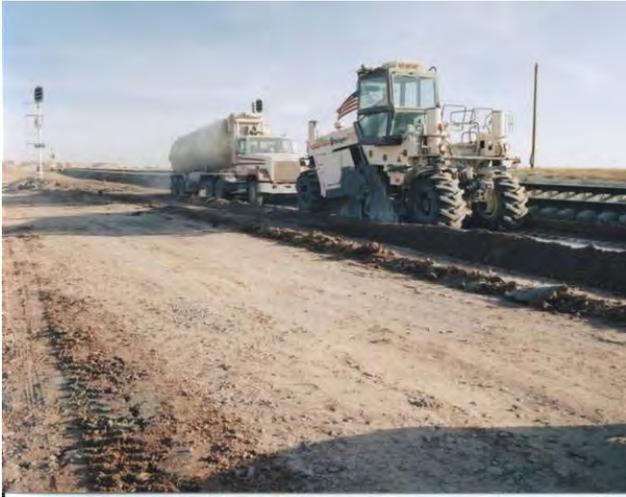
Lime stabilization (Figure 5) was performed on the outer portions of the subgrade clay when there was over excavation. It was lime stabilized over the entire surface when no over excavation was required to strengthen the clay and prevent the surface softening. The lime would also improve the plasticity characteristics and reduce the swelling and shrinkage potential of the clay subgrade.

Figure 5: Lime Stabilization Equipment

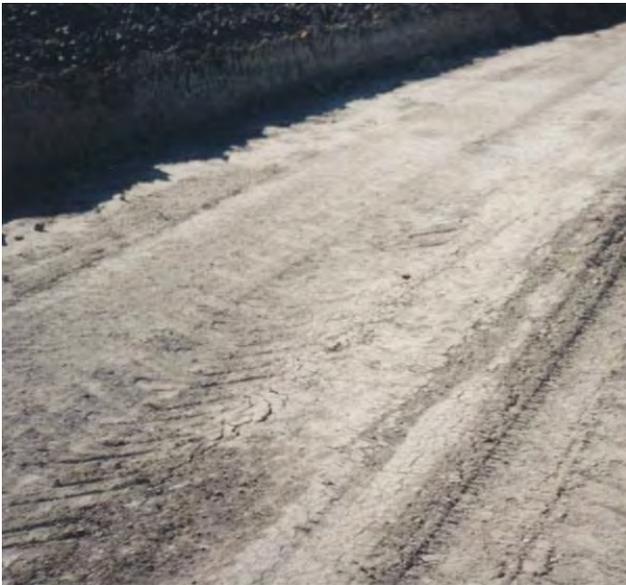
Figure 6 shows the lime stabilized subgrade before final grading and compacting.

Figure 6: Lime Stabilized

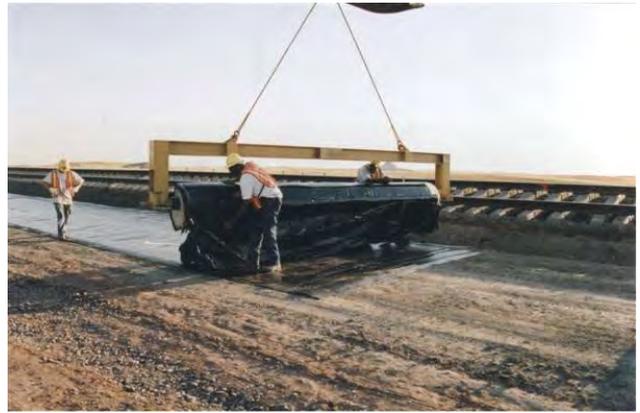
Due to the durability of the geomembrane, it was possible to place the membrane without the use of a separate geotextile protection (Figure 7). This helped to improve the speed of installation, maximized the friction interface with the base, and reduced the overall cost.

Figure 7: Placing the Membrane

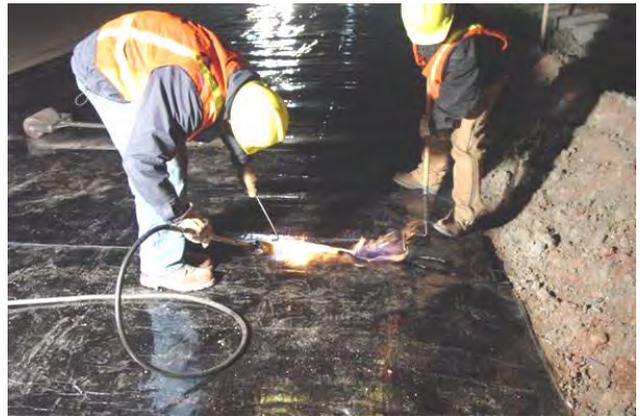
As each roll is completed, the next roll is welded to the previous using a simple yet effective thermal welding process. The simplicity and effectiveness of the welding method for this type of geomembrane liner is a major benefit. The end of each roll of geomembrane is lifted slightly, and a propane gas torch is used to heat and liquefy the bitumen (Figure 8). The two layers of material are then brought together and then rolled with a light hand held roller to produce a continuous seam. The very edge is then heated and toweled over to remove any possibility of failure.

Figure 8: Welding the Membrane

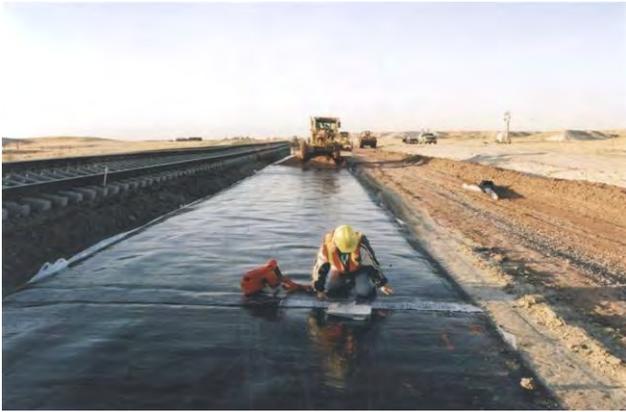
All seams in the geomembrane were tested for defective welds using an ultrasound device (Figure 9). With this it is possible to establish the integrity of all welds with complete confidence. An ultrasound pulse is generated by a transducer, which also detects the reflected signal from the underside of the weld, displaying the readout on a screen as two peaks. Any defects show up as a secondary peak and the area can be marked for remedial action – repair is simple, by cutting, re-welding and then placing a patch over the repair overlapping by 200 mm.

Figure 9: Inspection of Welds

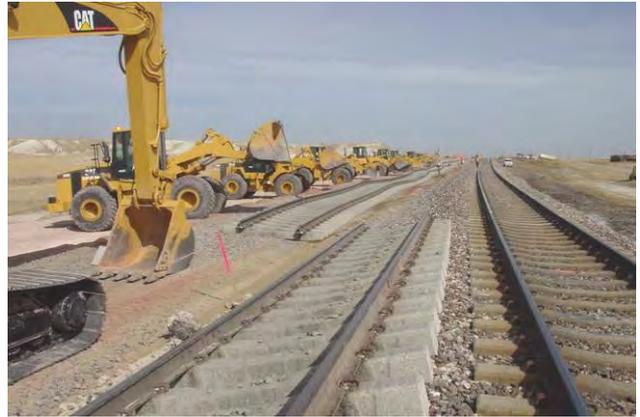
Figure 11: Replacement of Track

The bottom dump trucks first deposited subballast along the edge of the membrane. Then the blades plowed the subballast on top of the membrane to prevent vehicle traffic from causing wrinkles. Next a thin layer of ballast was placed followed by replacing the track panels (Figure 11). The remaining steps were to deposit the additional ballast, raise the track to grade, and tamp the ballast.

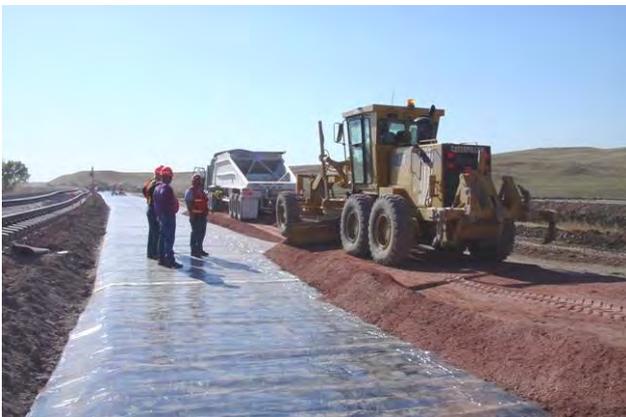
Subballast was placed directly on top of the geomembrane without the use of geotextile protection (Figure 10). It would have also been acceptable to place the ballast directly on the geomembrane; however, due to grade requirements for the final track it was less expensive to use subballast. This ability to accept ballast or subballast is unique to a bituminous geomembrane.

Figure 10: Sub-Ballast Placement
