Protecting railway sub-grade with a reinforced bituminous geomembrane

G. LANGLEY, Colas Inc., B. BREUL, Colas SA,
E. SELIG, Ernest T. Selig, Inc., J. HYSLIP, Ernest T. Selig, Inc.

ABSTRACT: As part of a continuing effort to improve the reliability and efficiency of key sections of railway, The Burlington Northern and Santa Fe Railway Co. (BNSF) identified several sections of track requiring refurbishment. The problem was found to be related to the softening of the clay subgrade surface from water entering the track substructure. The solution that Engineers at BNSF chose was to treat the upper part of the clay with lime and cover the clay surface with bituminous geomembrane liner system to inhibit water from coming into contact with the surface of the plastic clay.

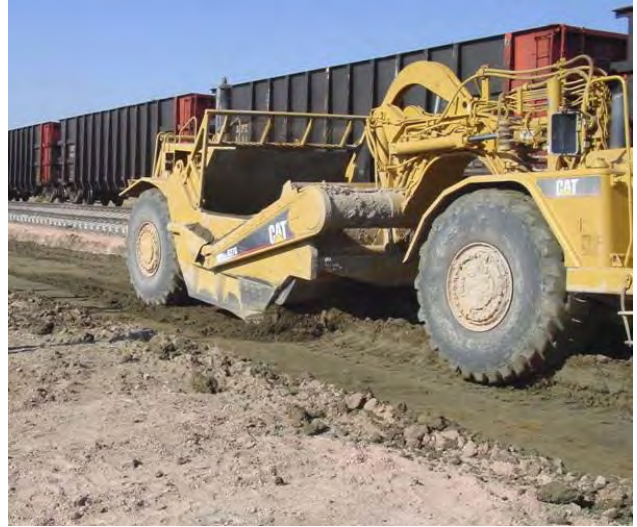
Figure 3: Base Preparation

Preparation of the base involved the removal of the existing ballast, subballast and the very soft clay surface (Figure 3). In areas where the clay was soft, as observed by rutting from the scrapers (Figure 4) the soft material was excavated and replaced with subballast.

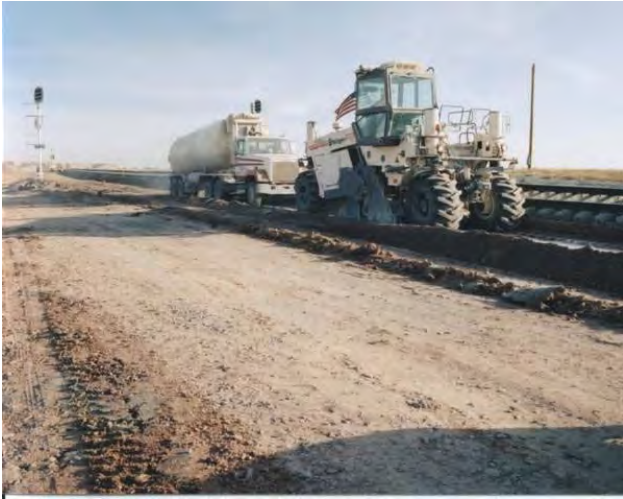
Figure 5: Lime Stabilization Equipment

Lime stabilization (Figure 5) was performed on the outer portions of the subgrade clay when there was over excavation. It was lime stabilized over the entire surface when no over excavation was required to strengthen the clay and prevent the surface softening. The lime would also improve the plasticity characteristics and reduce the swelling and shrinkage potential of the clay subgrade.

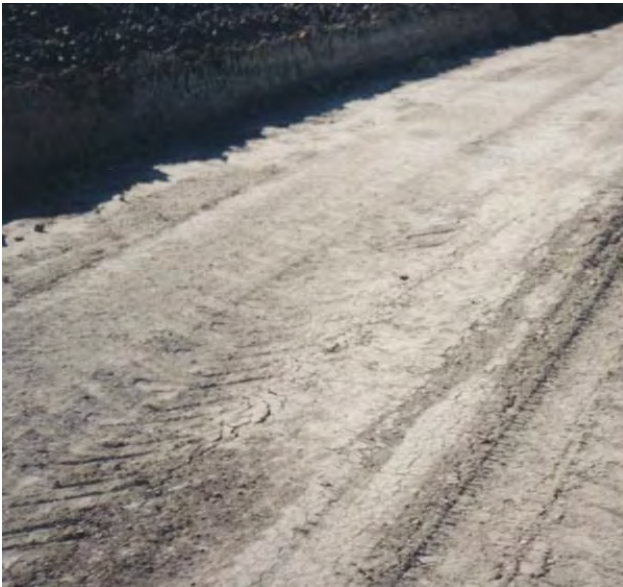
Figure 6: Lime Stabilized

Figure 6 shows the lime stabilized subgrade before final grading and compacting.

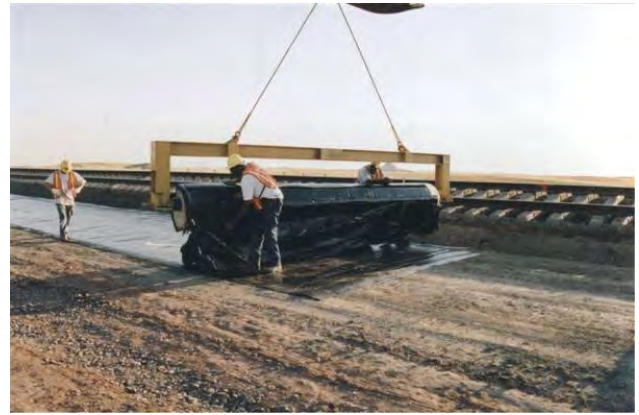
Figure 7: Placing the Membrane

Due to the durability of the geomembrane, it was possible to place the membrane without the use of a separate geotextile protection (Figure 7). This helped to improve the speed of installation, maximized the friction interface with the base, and reduced the overall cost.

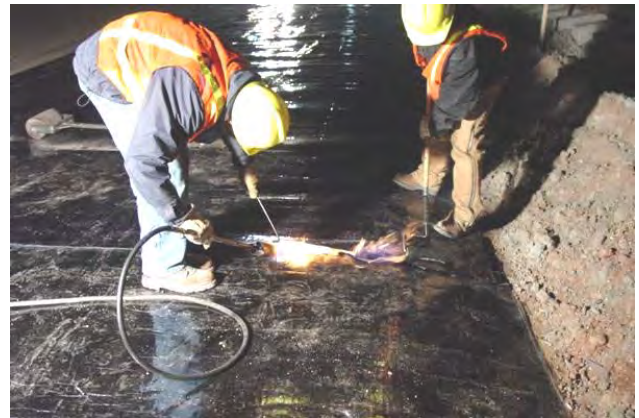
Figure 8: Welding the Membrane

As each roll is completed, the next roll is welded to the previous using a simple yet effective thermal welding process. The simplicity and effectiveness of the welding method for this type of geomembrane liner is a major benefit. The end of each roll of geomembrane is lifted slightly, and a propane gas torch is used to heat and liquefy the bitumen (Figure 8). The two layers of material are then brought together and then rolled with a light hand held roller to produce a continuous seam. The very edge is then heated and toweled over to remove any possibility of failure.

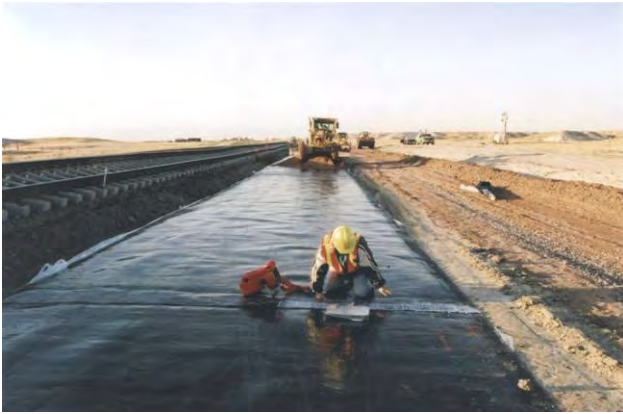
Figure 9: Inspection of Welds

All seams in the geomembrane were tested for defective welds using an ultrasound device (Figure 9). With this it is possible to establish the integrity of all welds with complete confidence. An ultrasound pulse is generated by a transducer, which also detects the reflected signal from the underside of the weld, displaying the readout on a screen as two peaks. Any defects show up as a secondary peak and the area can be marked for remedial action – repair is simple, by cutting, re-welding and then placing a patch over the repair overlapping by 200 mm.

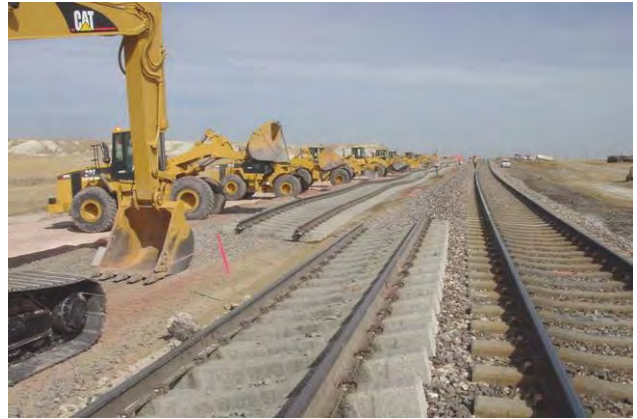
Figure 11: Replacement of Track

The bottom dump trucks first deposited subballast along the edge of the membrane. Then the blades plowed the subballast on top of the membrane to prevent vehicle traffic from causing wrinkles. Next a thin layer of ballast was placed followed by replacing the track panels (Figure 11). The remaining steps were to deposit the additional ballast, raise the track to grade, and tamp the ballast.

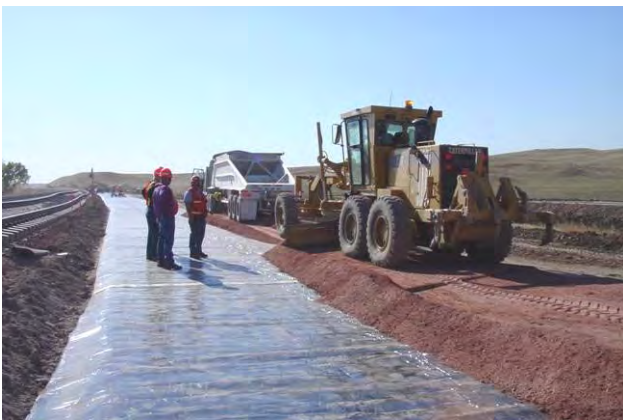
Figure 10: Sub-Ballast Placement

Subballast was placed directly on top of the geomembrane without the use of geotextile protection (Figure 10). It would have also been acceptable to place the ballast directly on the geomembrane; however, due to grade requirements for the final track it was less expensive to use subballast. This ability to accept ballast or subballast is unique to a bituminous geomembrane.
